**BLACKSTONE RIVER BASIN  
WORCESTER, MASSACHUSETTS**

**COES RESERVOIR DAM  
MA 00120**

**PHASE I INSPECTION REPORT  
NATIONAL DAM INSPECTION PROGRAM**

**AUGUST, 1978**

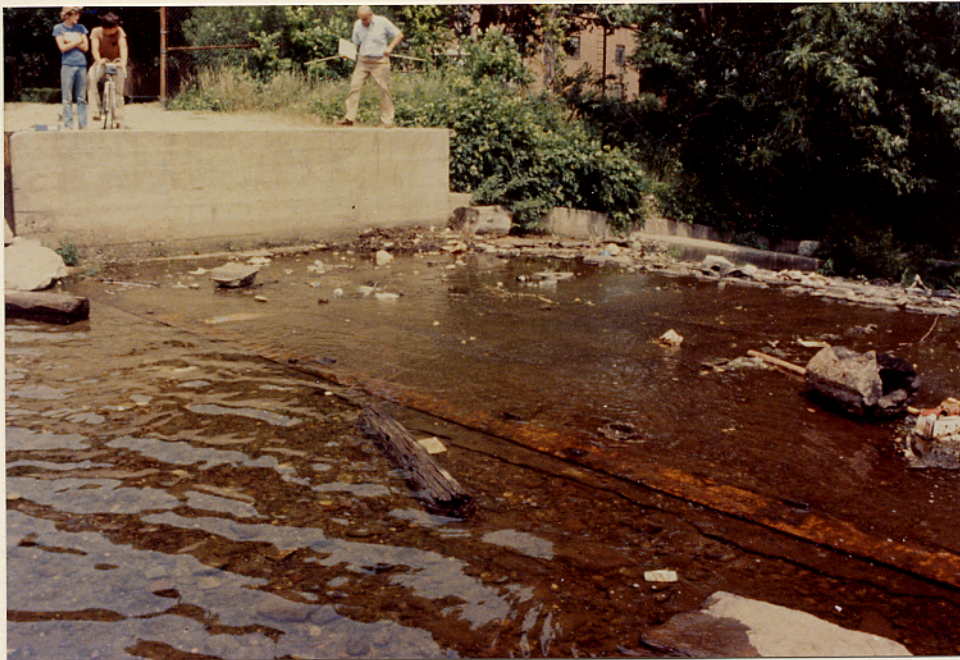
The concrete on the spillway crest is cracked and eroded in places. Debris such as wood, stones, and trash is scattered on the crest. The stonework in the north training wall is loose and has fallen out of place. In the downstream channel, the concrete side channel is broken and tilted out of place, and sections of the south wall have collapsed. Seepage enters the concrete channel from the base of the north wall about 35 feet below the spillway crest. Trash and other debris is scattered on the floor of the channel. Dense vegetation occurs along both walls of the discharge channel and on the bottom of the channel along the north wall. The growth is mostly brush and small trees, but three large (12-inch to 36-inch diameter) trees are growing on the north side. One tree is near where seepage is flowing into the concrete side channel.

NO. 1 VIEW OF SPILLWAY CREST AND NORTH ABUTMENT

- (3) Repair the eroded concrete on the spillway weir; repair the loose stonework on the north training wall of the spillway; and remove the south wall of the concrete side channel in the discharge channel. These would be interim measures until a new spillway is constructed.

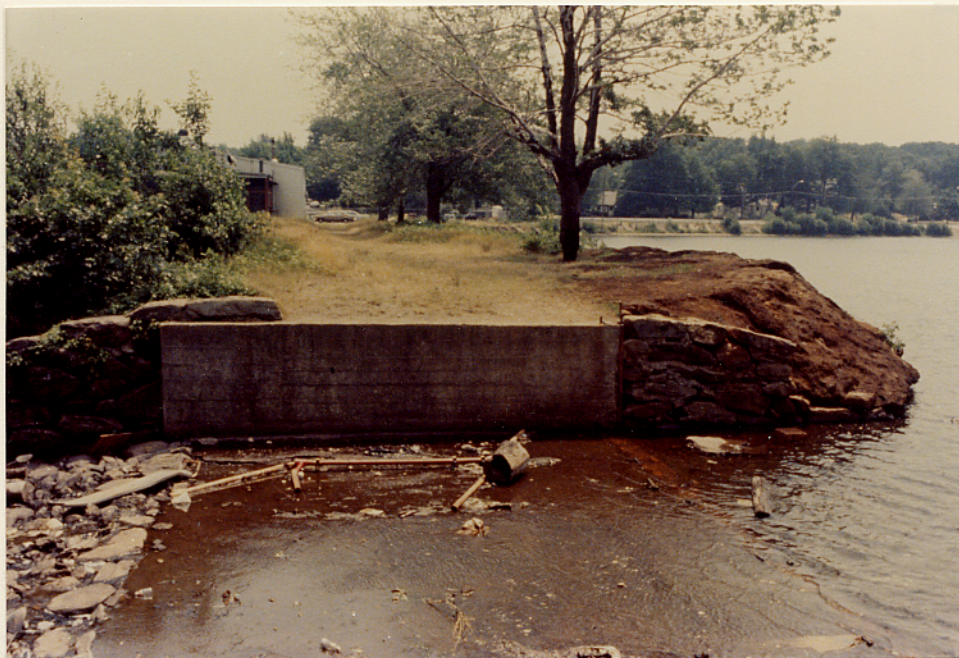
NO. 2 VIEW OF SPILLWAY CREST AND DAM EMBANKMENT

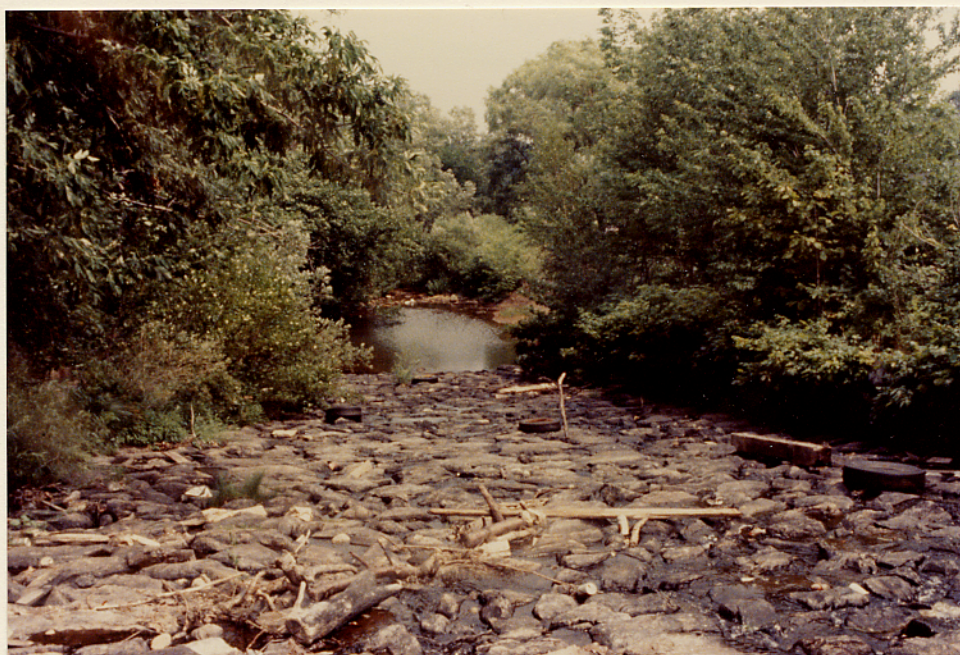
c. Discharge Channel **	sloping stone-lined channel w/dry stone masonry sidewalls; conc. side channel along no. wall
General Condition	channel + walls-fair; concrete side channel-v. poor, cracked + broken, weed + brush growth, seepage at 1/3 ds from base of north side wall
Loose Rock Overhanging Channel	dry-stone masonry wall at downstream end of channel on north slope
Trees Overhanging Channel	36", 18", 12" trees on north side-one is opposite seepage @ base of wall; small trees on south side
Floor of Channel	scattered debris, some vegetation, fallen sections of concrete side channel
Other Obstructions *	18" dia. metal drain pipe discharging at ds end, north side of channel, near stone wall

NO. 3 VIEW OF SPILLWAY CHANNEL

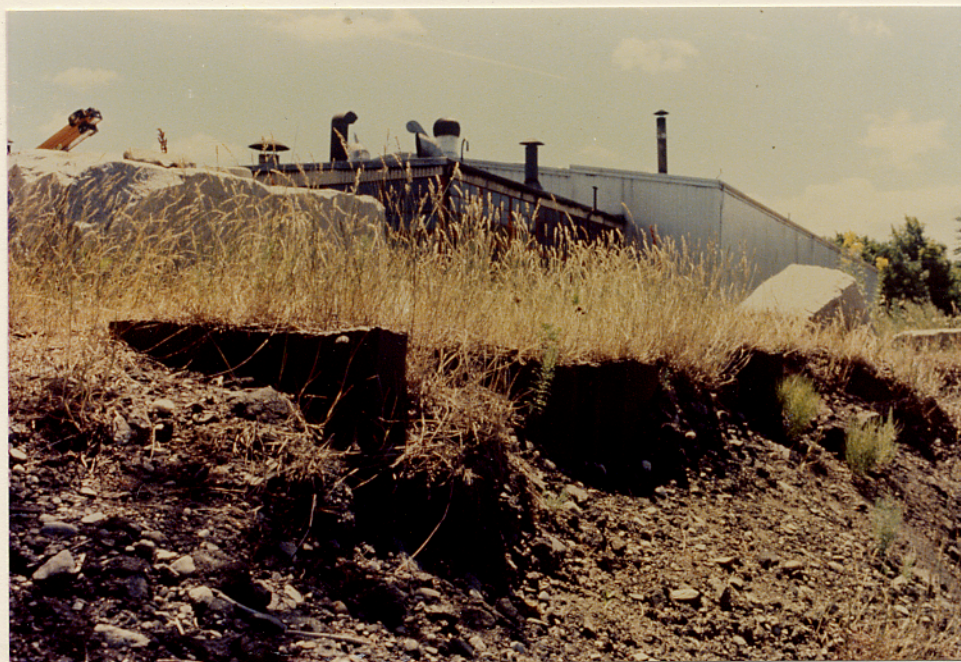
Several signs of distress were observed, the most significant being erosion of the upstream face of the dam which is generally a 1:1 slope without riprap. In several places on the upstream face, the grinding grit is being undermined by wave erosion, causing local sloughing of the slope. The dam section just north of the spillway consists of sand which has been eroded. In this area, undercutting of the bank along the upstream edge of the crest has caused portions of a chain-link fence to fall.

NO. 4 VIEW OF UPSTREAM FACE OF DAM

- (1) Construct an adequate spillway for the dam, and a gated outlet, based on hydraulic and hydrologic studies recommended in 7.2.b.
  - (2) Repair upstream embankment slopes by filling in eroded areas, flattening the slope, and protecting it with riprap.

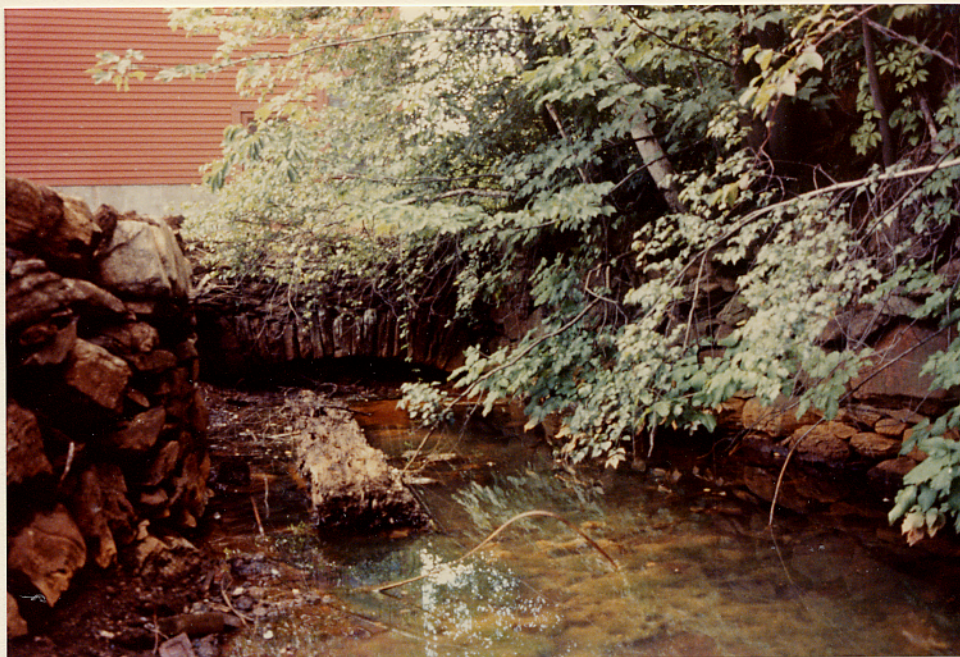
NO. 5 VIEW OF TAILRACE OUTLET AND CHANNEL

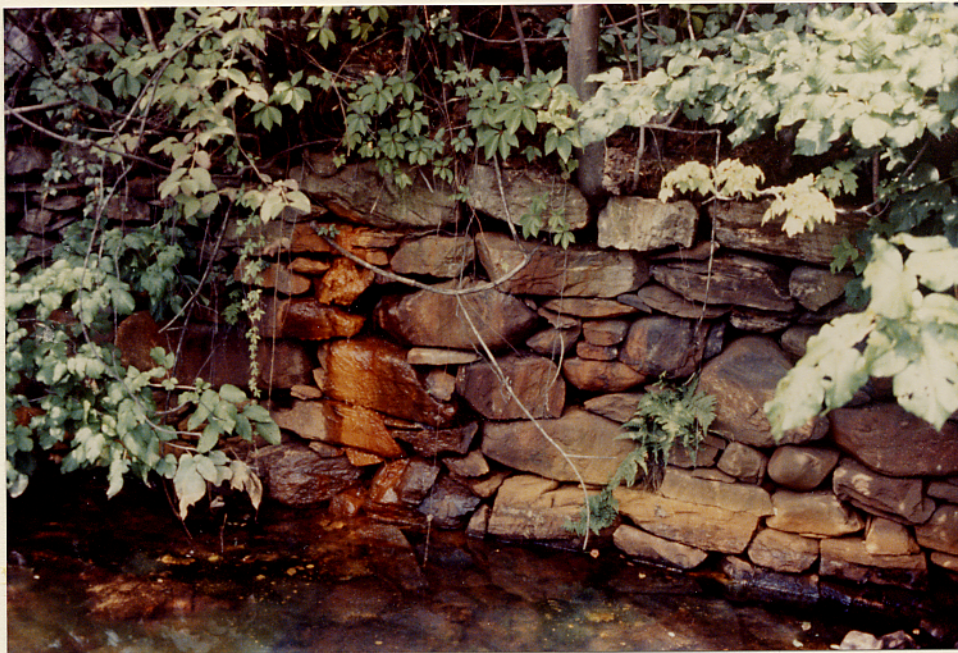
inches in diameter, are growing there. The upstream face has a moderate growth of brush, and the downstream face is heavily overgrown with brush and small trees. Seepage was observed entering the tailrace from around tree roots embedded in the upstream side wall of the channel.

NO. 6 VIEW OF SEEPAGE FROM WEST WALL  
OF TAILRACE CHANNEL

It is recommended that a more detailed investigation be initiated to evaluate the stability of the dam and the seepage at the downstream masonry wall.
